Freisland Ditch Culvert Rehabilitation

CNA Consulting Engineers provided the design for rehabilitation of a liner plate arch culvert under I-35 near Hinckley, Minnesota. The culvert suffered from corrosion at the waterline and excessive deformation in the upper arch. Timber posts and beams had been installed by maintenance crews for temporary support. The rehabilitation included installing steel posts and spreaders, removal of the wood supports, pouring a concrete invert, shotcreting the upper arch, and removal of all the steel posts.

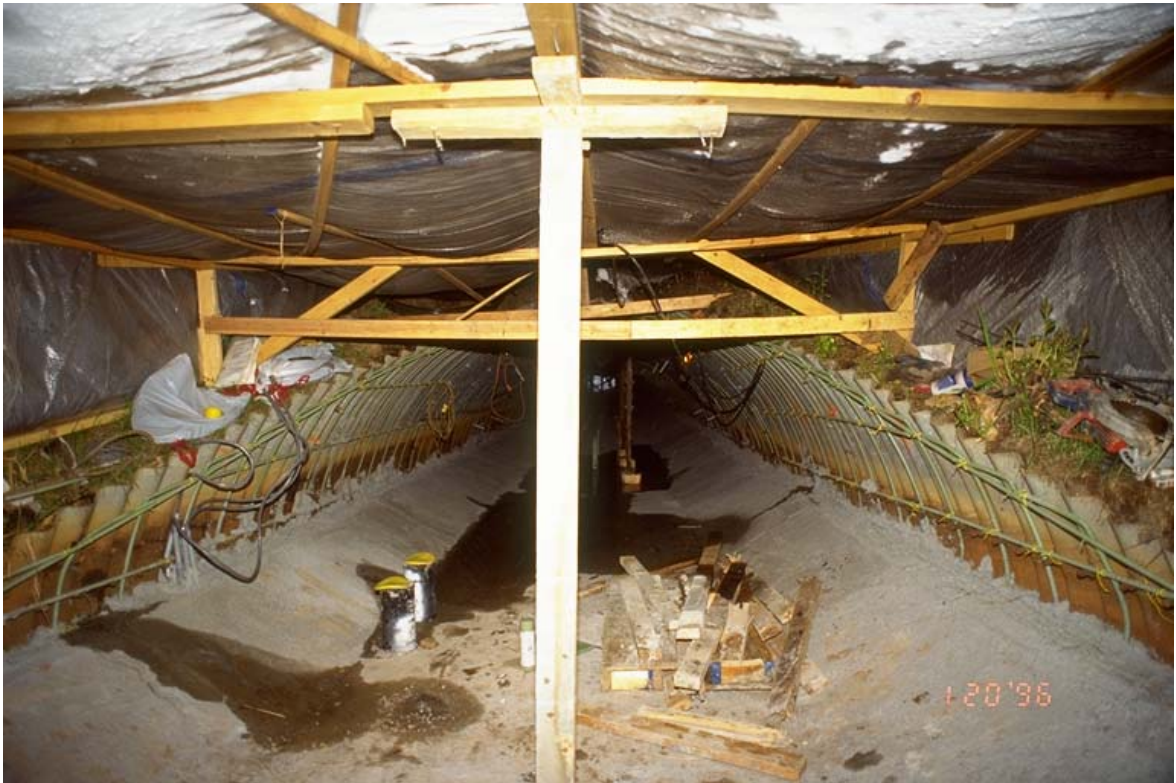
Invert concrete and arch rebar in place with winter snow shelter overhead

This was a pilot project to develop evaluation and repair methods for distressed liner plate structures. Sections were lined with four different combinations of dry and wet shotcrete and bar and fiber steel reinforcement. Various instruments were installed, including: strain and stress gauges, delamination gauges, and extensometers. After the repair, test loads were applied and the performance recorded.
